## Failure analysis of water wall tubes in coal fired power plant

Arvind Kumar\* and Janardhana M \*\*

*One of power generating utility has reported the failure of boiler water wall tubes after a service life of 10,000 hours against the design life of 30-35 years. The failure of tubes was reported in water wall tubes regions which consist of carbon steel alloy. These boiler tubes were operating under the oxidizing/reducing atmosphere at high temperature and pressure. This paper represents the investigation the failure of water wall tubes used in a coal fired thermal power plant. The failure investigation covers visual inspection, dimensional measurement, hardness mapping, deposit flux measurement and SEM & EDX analysis of the deposited products. This paper is the case study of failure analysis of water wall tubes due to corrosion and ID deposition on the tube. The analysis reveals that the failures were due to inside corrosion and hydrogen damage attack.*

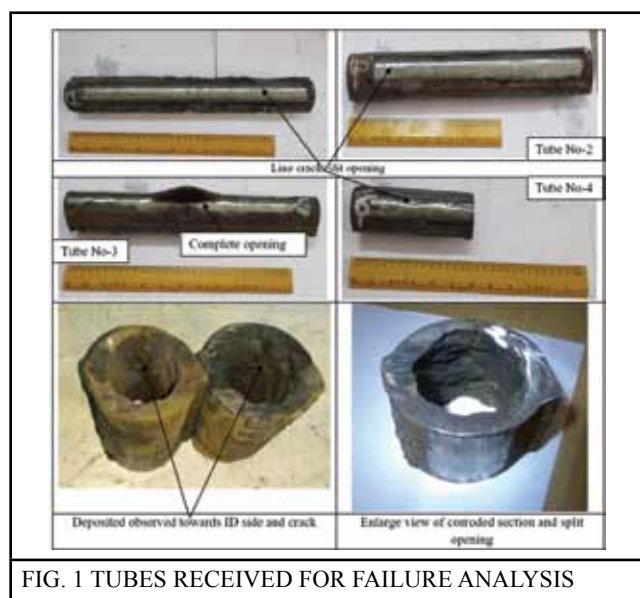
FIG. 1 TUBES RECEIVED FOR FAILURE ANALYSIS

A line/ slit type opening were observed in the longitudinal direction on the outer side of the Tube Nos. 1, 2 & 4 while a complete opening like fish mouth opening were observed on the Tube No 3.

ID deposit and gouging were observed on the Tube Nos. 1, 2 & 4. Internal metal losses were also observed on the inner side of the tube at some localized section. Deposited materials were observed mostly along the cracked/slit opening section, which were localized.

The thicknesses of the tubes were within the range of 7 to 8.9 mm except the corroded region where the minimum thicknesses was observed as 5.8 mm.

No bulging was observed on the tubes (outer Diameter from 51 to 53 mm) except the Tube No 3 (fish mouth opening) the outer diameter was noted as 65 mm at the ruptured section.

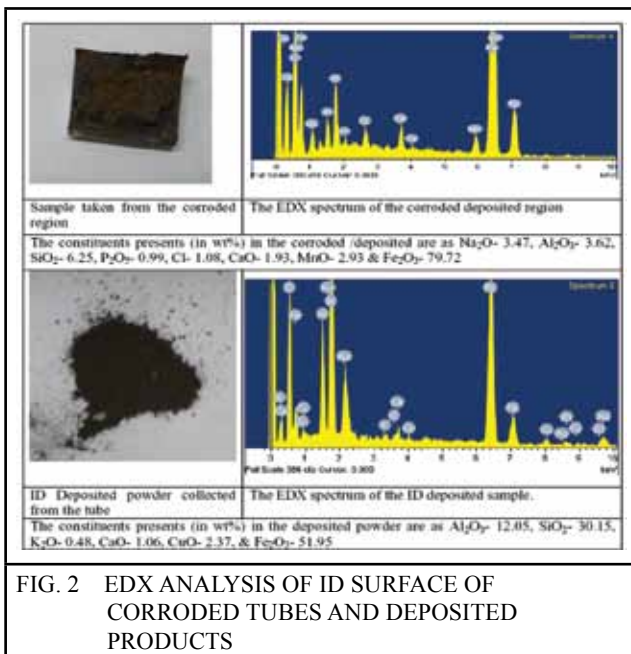
FIG. 2 EDX ANALYSIS OF ID SURFACE OF CORRODED TUBES AND DEPOSITED PRODUCTS

The EDX analysis of the corroded and gouging area reveals the major constituents of iron oxide with small amounts of oxides of sodium, aluminum, silicon, manganese, calcium, potassium, chlorine and phosphorous.

The EDX analysis of ID deposits powder shows as major constituents as iron oxide, silica and oxide of aluminum with small amounts of copper, calcium and potassium.

From the EDX analysis of the corroded section of the tube and ID deposited constituents, it is observed that corrosive constituents (Na, Cl,

P, K) are still present that caused the pitting of the tube towards the ID side. These corrosive environments caused the localized pitting to the ID side of the tube.

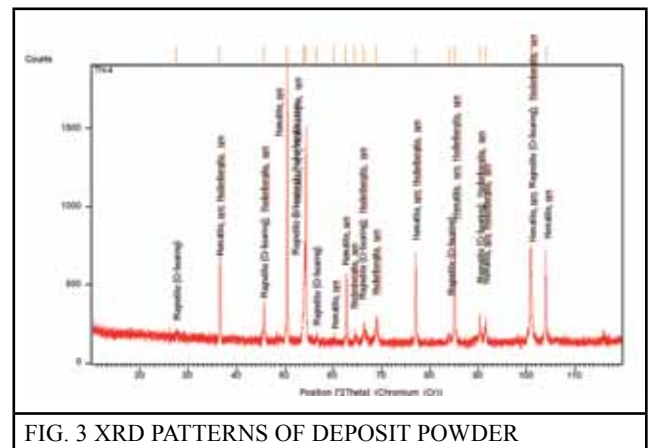
FIG. 3 XRD PATTERNS OF DEPOSIT POWDER

The deposit was analyzed from X-ray diffraction technique (PANalytical, make- X' PertPRO The Netherlands) to analyze the phases present in the powder. The analysis of the deposit powder shows mainly oxides of iron in hematite and magnetite form. The XRD pattern is given below in Figure 3.

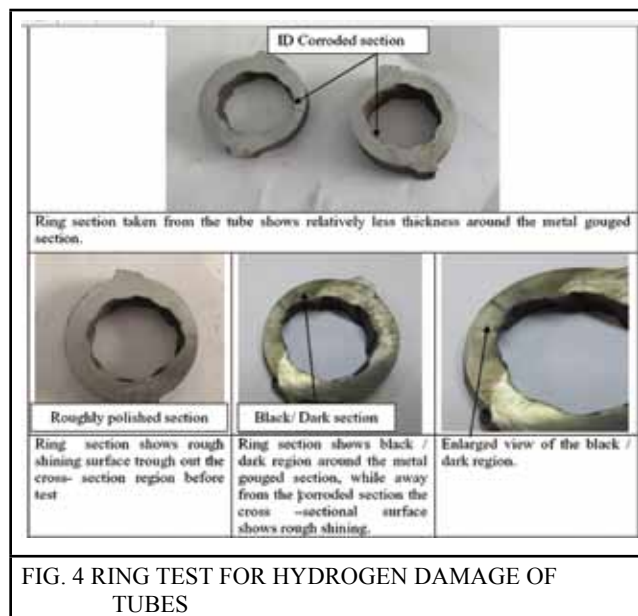
A ring section type sample was taken from the high flux deposited sample i.e. from Tube No.4. The ring sample was coarse polished with emery paper (silicon carbide) of 220 grit paper followed by 600 grit paper to give the surface a rough shining surface. After the polishing the ring section was macro etched in a solution of hydrochloric acid for few minutes. The ring sample was taken out and washed it in running tap water for few minutes and dried at room temperature. It is observed that some section of the ring sample turned dark near the corroded area and partially also through the tube wall section, while other section of the ring sample was not dark as shown in Figure 4. The dark section of the ring sample is the indication of attack i.e. hydrogen damage. The tube has failed due to hydrogen damage.
