# Review of Failed Transmission Line Towers during Full Scale Testing

M. Selvaraj and Veerendra Kumar Shukla\*

Mechanical Engineering Division, Central Power Research Institute (CPRI), Bangalore – 560080, Karnataka, India;  
vshuklacivil@gmail.com

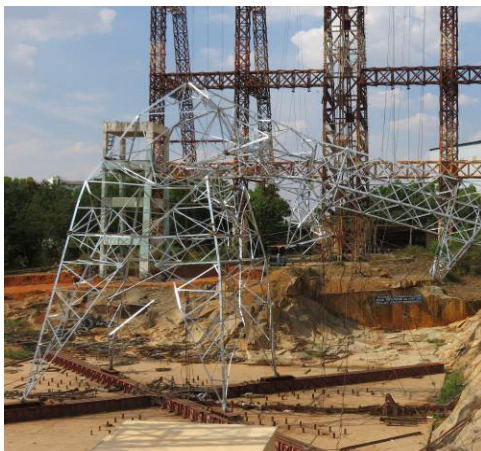
**Figure 1.** 230kV double circuit suspension tower.

**Description:** While increasing to 90%, of Vertical and Transverse loads, the whole tower failed. Failure started from Leg member and subsequently the whole tower collapsed (Figure 1). It was decided to review the design of tested tower, and scheduled to test again after necessary modification.

Tower after failure

**Remedial Measures:** Since the whole tower was collapsed, it was not possible to do any remedial measure. The tower was reanalyzed, modified and re-tested successfully.

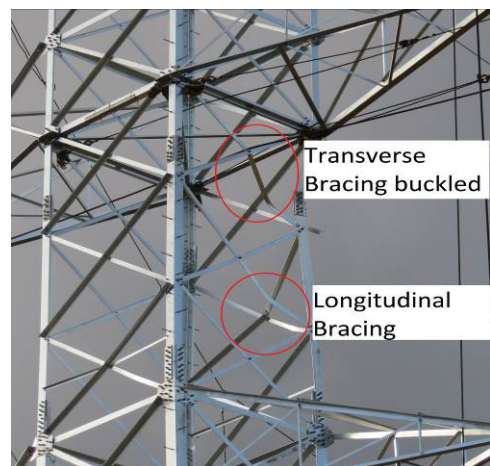
**Figure 2.** 220kV double circuit Tension tower.

**Description:** While increasing the loads from 75% to 90%, two Transverse bracing members and one Longitudinal bracing member buckled (Figure 2). Subsequently, Main leg got buckled below Ground wire level. The loads were released immediately.

Figure showing Buckled bracing

**Remedial Measures:** The failed members were 80X80X6 MS Angle Section, after reanalyzing the tower, the existing member was replaced by 90X90X6 MS Angle Sections in the erected tower. Horizontal redundants of 45X45X5 MS size were also introduced on both transverse and longitudinal face to reduce the unsupported length of main member. After these remedial measures, the test was continued again and the tower was successfully tested.

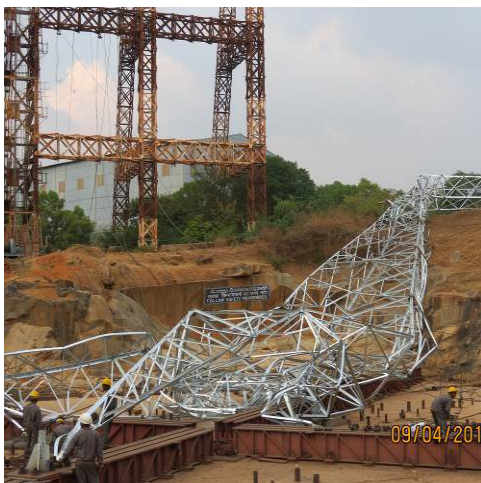
**Figure 3.** 220kV double circuit Tension tower.

**Description:** During waiting period after reaching 100%, of all loads, the tower failed. The failure occurred at compression leg members at the junction of first and second panel below waist level, (Figure 3). They started bowing outward. Subsequently the whole tower collapsed.

Failed Tower

**Remedial Measures:** The tower was reanalyzed and after modification it was tested successfully.

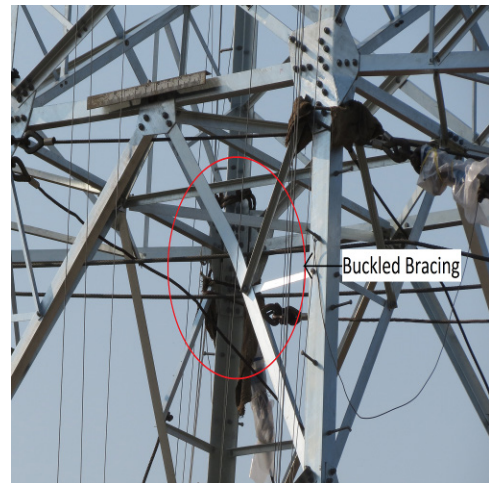
**Figure 4.** 220kV double circuit tension tower.

**Description:** During waiting period after 300 seconds, it was observed, that some bracing members of transverse and longitudinal face are slightly buckled, (Figure 4). The load was released immediately.

Failed Tower

**Remedial Measures:** The buckled members were modified after reanalyzing the tower design. The existing member size L80X80X6 MS was replaced by L90X90X6 MS and L75X75X6 MS was replaced by L80X80X6 MS.

The tower was tested again after these modifications the tower was successfully withstood the loads under the above loading condition.

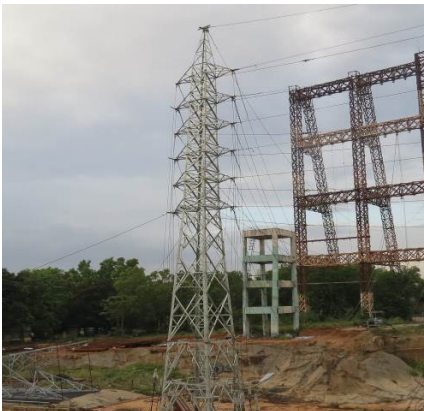
**Figure 5.** 66kV multi circuit tension tower.

**Description:** After completion of 240 seconds waiting period, it was observed that, redundant members of transverse side buckled (Figure 5). The loads were released immediately.

Figure showing position of Buckled redundant

**Remedial Measures:** The buckled redundant members of existing size L45X30X4 were replaced by L45X45X4 and the test was continued again. The tower

was successfully withstood all the loads under the specified loading condition.

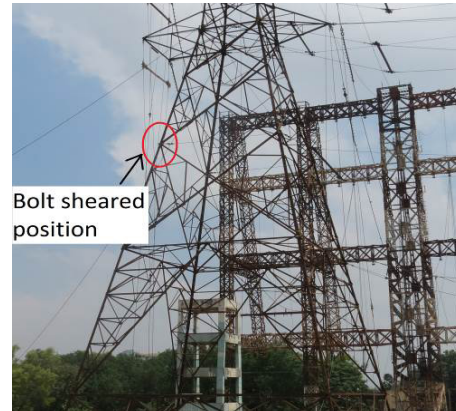
**Figure 6.** 220kV double circuit tension tower.

**Description:** While increasing all loads from 75% to 90%, one bolt sheared off at the joint of bracing and leg [Figure 6]. The loads were released immediately.

Figure showing location of Sheared bolt

**Remedial Measures:** The bolt was replaced without any other modification in the tower. The testing was continued again and the tower was successfully –withstood all the loads under the above loading condition.

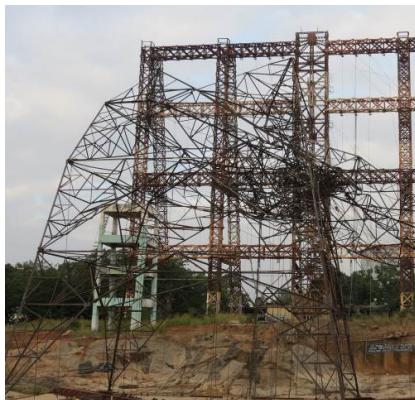
**Figure 7.** 230kV double circuit suspension tower.

**Description:** While increasing load from 95% to 100%, the tower failed. The failure started from leg member, which buckled below basic body and subsequently the whole tower collapsed, [Figure 7].

Fully collapsed tower

**Remedial Measures:** It was decided to reanalyze the tower design and after modification it was rescheduled for testing. The new tower was erected and retested successfully.

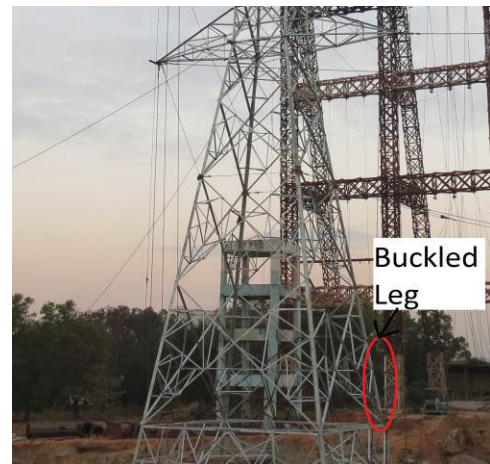
**Figure 8.** 330kV double circuit tension tower.

**Description:** Just after reaching 100% of all the loads, the tower failed. Failure started from Transverse bracing members and subsequently Leg members of Longitudinal side got buckled, [Figure 8]. All loads were released immediately.

Fully collapsed tower

**Remedial Measures:** Leg member of size L100X100X7 HT angle section was replaced by L100X100X8 HT angle section and bracing member was replaced with same size but unsupported length of the member was reduced by introducing L45X45X5 MS Angle sections. The tower was tested again and successfully withstood the loads pertains to the above loading condition.

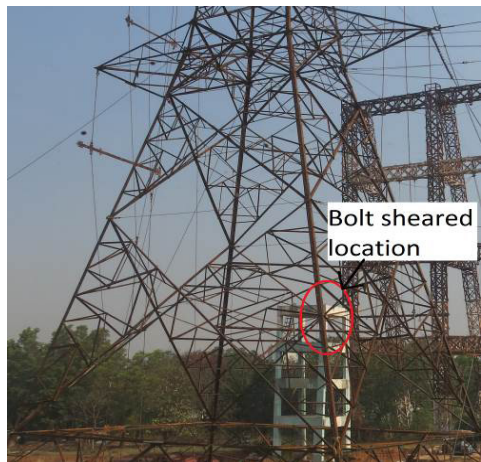
**Figure 9.** 400kV double circuit tension tower.

**Description:** After reaching 95% of loads, during waiting period, one bolt of Leg member was sheared off [Figure 9]. The loads were released immediately.

Figure showing the position of sheared bolt

**Remedial Measures:** The bolt was replaced by a new bolt of same grade and test was resumed. The tower successfully withstood the load pertains to the above loading condition.

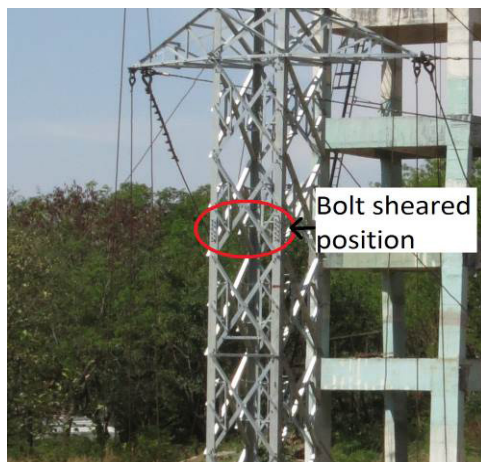
**Figure 10.** 132kV double circuit suspension tower.

**Description:** While increasing the transverse load to 100%, three bolts sheared off at the joint connecting Transverse Bracing and Leg [Figure 10]. The test was stopped immediately.

Figure showing the position of sheared bolt

**Remedial Measures:** The bolts were replaced with same grade bolts and the test was continued. The tower successfully withstood the load pertains to the above loading condition.

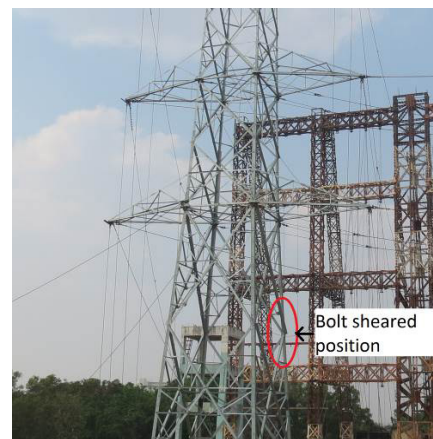
Figure 11. 132kV double circuit tension tower.

**Description:** During waiting period after reaching 100% of all the loads, some sound was heard from the tower [Figure 11]. On inspection, it was observed that one bolt was sheared off. The loading was stopped immediately.

Figure showing the position of sheared bolt

**Remedial Measures:** The bolt was replaced with same Grade bolt and the test was started again. The tower successfully withstood the entire load after this modification.
