Damage assessment of attemperator of thermal power plant boilers

Dhiraj M Gourkhede*

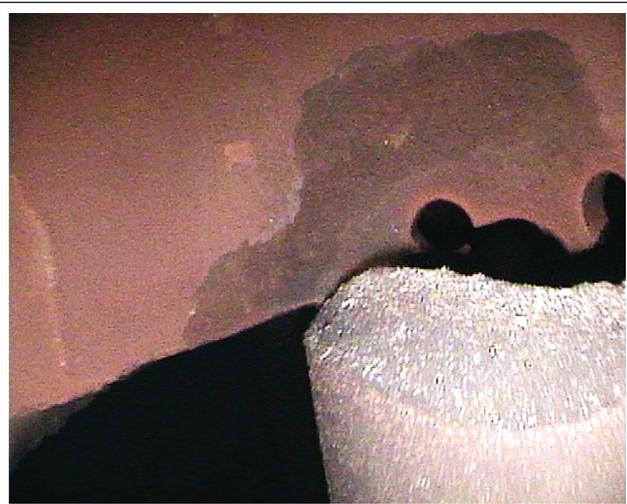
FIG. 3 IMAGE OBTAINED

The video images of specific locations that have shown the characteristic which are much different from the normal were recorded during the inspection. The imaging of the broken injector observed. The typical image obtained is shown in Figure 3.

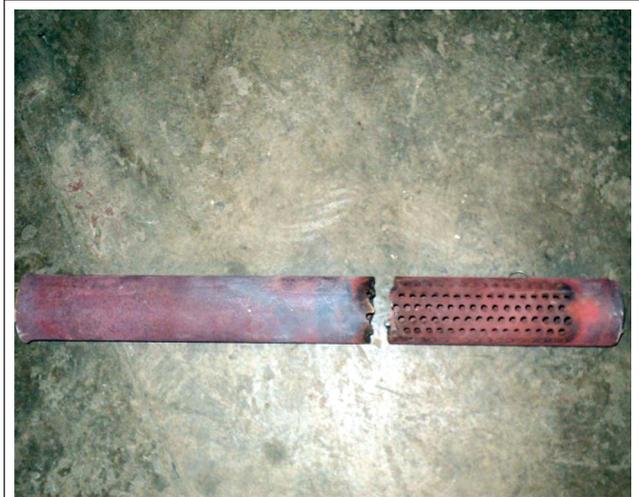
FIG. 5 IMAGE OF BROKEN INJECTOR TAKEN OUT FROM ATTEMPERATOR

In direct contact desuperheating, injector carries attemperating water for controlling the steam temperature and avoiding the consequences associated with droplet impact on hot pressure parts. Due to broken injector, mainly due to fatigue failure caused by flow-induced resonance, the water directly impinges on the attemperator shell. The increase in hardness is mainly due to the quenching effect due to broken injector, which makes the attemperator shell brittle which is prone to failure.

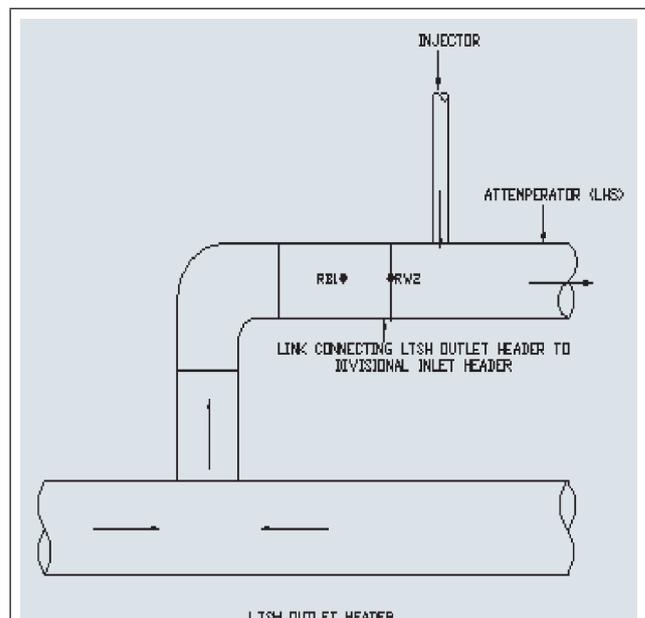
FIG. 6 ATTEMPERATOR (LHS)

In-situ Metallography and Hardness measurement was carried out near the broken injector on pipeline (Shell) as shown in the Figure 5.

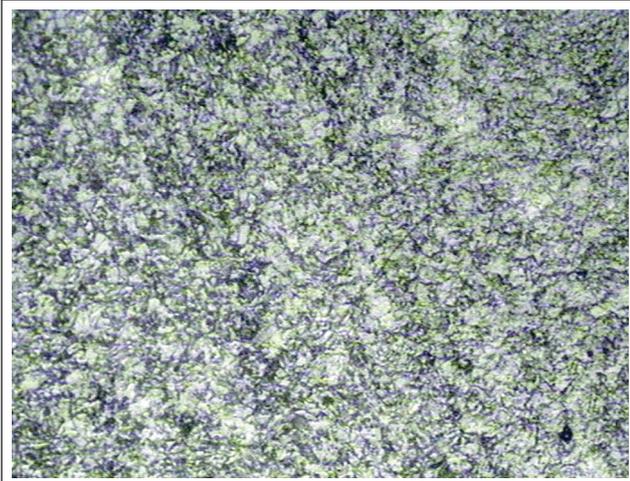
FIG. 7 REPLICA NO. R1B, MAGNIFICATION – 100X

TABLE 1						
INSITU METALLOGRAPHIC REPLICATION & HARDNESS TEST RESULTS						
Sl. No.	Component Details	Replica No.	Location	Microstructure details	Magnification	Hardness in HB
1	Attemperator (LHS)	R1B	At the Parent Metal near Weld (LHS)	Ferrite with bainite.	100X	172 - 174
		R2W	At the Dish End Weld (LHS)	Degenerated and coarse bainite, moderately high hardness.	100X	338 - 340

Metallurgical analysis on the base and weld metal was conducted through in-situ metallography (replication) on external surface. The microstructure was further analysed in the laboratory and it reveals Ferrite & Bainite with slight higher hardness on base metal. The Microstructure of weld metals reveals Degenerated and coarse bainite, moderately high hardness [7].

In-situ heating the attemperator shell to a temperature approximately 40-75°C (105-165°F) below the A1 transformation temperature — about 727°C (1340°F) for steel at approximately 670°C. The elimination of stress is not instantaneous (that is, the process is a function of both temperature and time). To achieve the maximum benefit, some time at temperature (typically one hour per 25 mm of cross-sectional area once the part has reached temperature) is required. In this case for two & half hours (Soaking time). This removes more than 90% of the internal stresses. After In-situ heating, the part is cooled at the rate of 100°C per hour upto 400°C and thereafter air cooled in still air. Rapid cooling will only serve to reintroduce stress and is the most common mistake made in stress-relief operations. The metallurgical changes

from the above act can reduce the hardness of the structure, improving ductility and reducing the risks of brittle fracture [8-9].

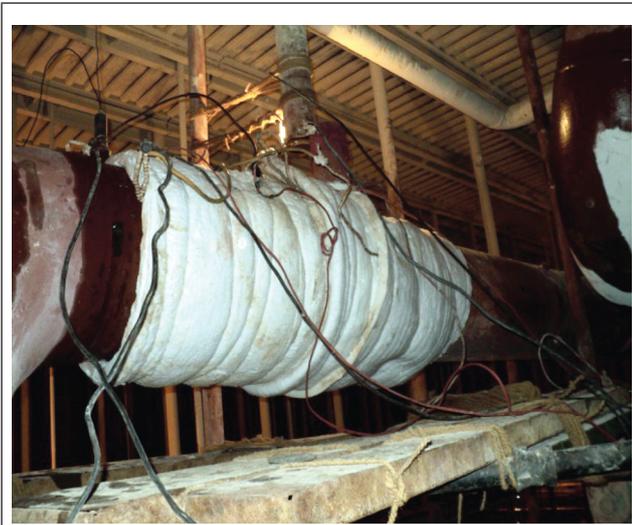
FIG. 10 IMAGE OF IN-SITU HEAT TREATMENT OF ATTEMPERATOR (LHS)

After the heat treatment of attemperator shell (LHS) a normal metallurgical structure consisting of ferrite & bainite observed. The hardness value achieved within normal range

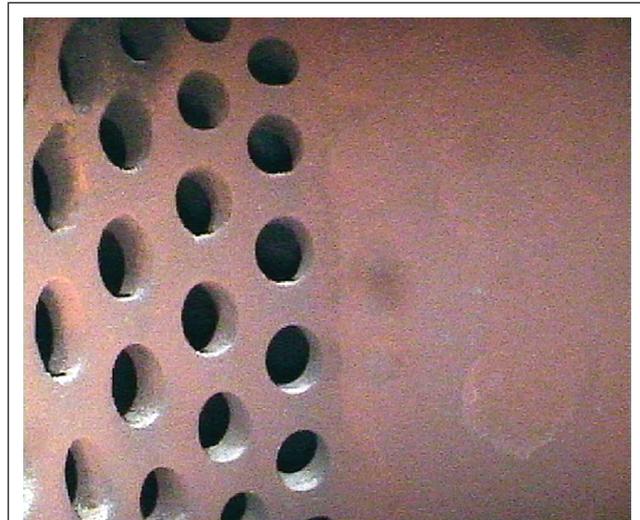
FIG. 11 IMAGE OBTAINED

The video images show the injector was intact & no damages were observed. The typical image obtained is shown in Figure 10.

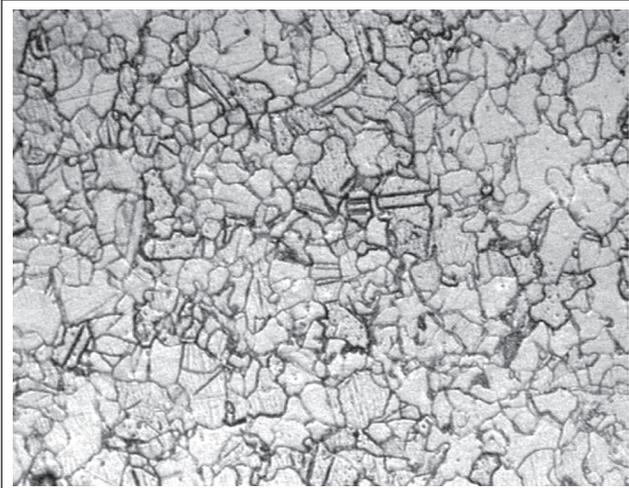
FIG. 13 REPLICA NO.-R3B, MAGNIFICATION – 100X

TABLE 2						
INSITU METALLOGRAPHIC REPLICATION & HARDNESS TEST RESULTS						
Sl. No.	Component Details	Replica No.	Location	Microstructure details	Magnification	Hardness in HB
1	Attemperator (RHS)	R3B	At the Parent Metal near Weld (LHS)	Ferrite growth, grain boundary thickening.	100X	133 – 136
		R4W	At the Weld (LHS)	Coarse bainite with Spheroidised carbide precipitation.	100X	226 – 228

Metallurgical analysis on the base and weld metal was conducted through in-situ metallography (replication) on external surface. The microstructure was further analysed in the laboratory and it reveals ferrite growth, grain boundary thickening on base metal. The Microstructure of weld metals reveals coarse bainite with spheroidised carbide precipitation [7]. The hardness readings were found within the acceptable range.

The metallurgical structure of the attemperator shell is normal; hence no further treatment is required.
