Analysis of Transformer Insulation by Tan Delta Testing Method

Dipak Mehta* and Hitesh R Jariwala**

This paper presents analysis of power transformer insulation by one fundamental insulation power factor test, also known as Tan Delta. It is a routine test conducted at site to know the healthiness of insulation in transformers. Out of 108 transformers tested for research work, case studies were chosen for analysis purpose. Experimental data shows our experience on the measurement of Tan Delta techniques of earthing systems and dryness of insulation in transformers. Result shows that the Tan Delta testing method is very efficient method.

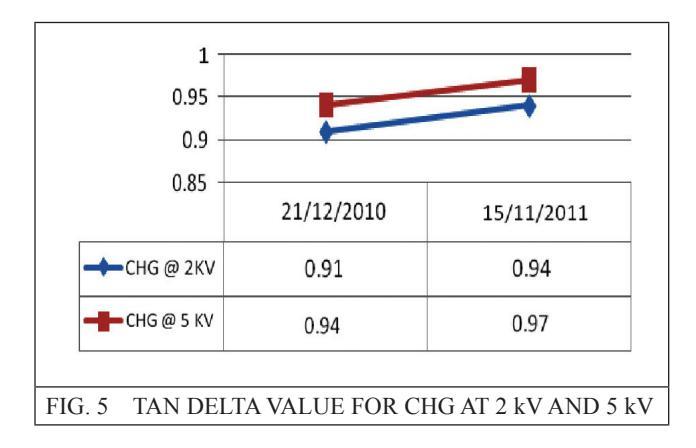
Above transformer is tested on 21/12/2010 for Tan Delta test and Tan Delta value was found to be much higher of CHG mode for both 2 kV and 5 kV as given in Table 2, all other values, found satisfactory and within limit according to IEEE-62 1995.

Hence, basically Tan Delta is a comparison method, so here during one year of span, the rate of increase of Tan Delta is much lower as given in Figure 5. So this transformer may be run as normal and yearly Tan Delta value shall be investigated.

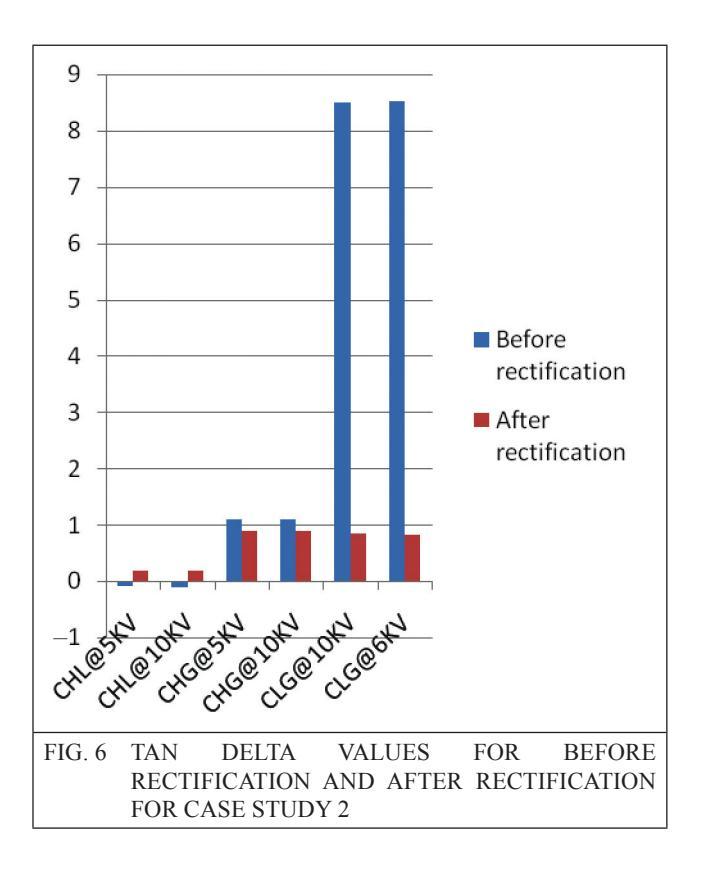
Figure 6 shows graphical representation of results for before fault rectification.

Above transformer was tested as a part of routine test. Capacitance and Tan Delta test were performed along with other low-voltage electrical tests and SFRA. SFRA and other electrical tests were indicative of normal condition of the transformer. While C and TD test data were not looking normal, decrement in capacitance and abnormal Tan Delta values (negative) were observed. Below Table 6 shows test results for case study 2. This being a new transformer, it was expected that Tan Delta test values will be found below 0.5 %. However, Tan Delta values of high-voltage winding were at 1 % while that of a low-voltage winding was much higher at over 8 %. Interwinding insulation exhibited negative Tan delta values.

Above transformer is opened at workshop and core earthing was found poor. The same was rectified and Tan Delta test was repeated and a comparison of the test data was made. Change in Tan Delta values of all the three winding configuration became normal and less than 0.5 %.

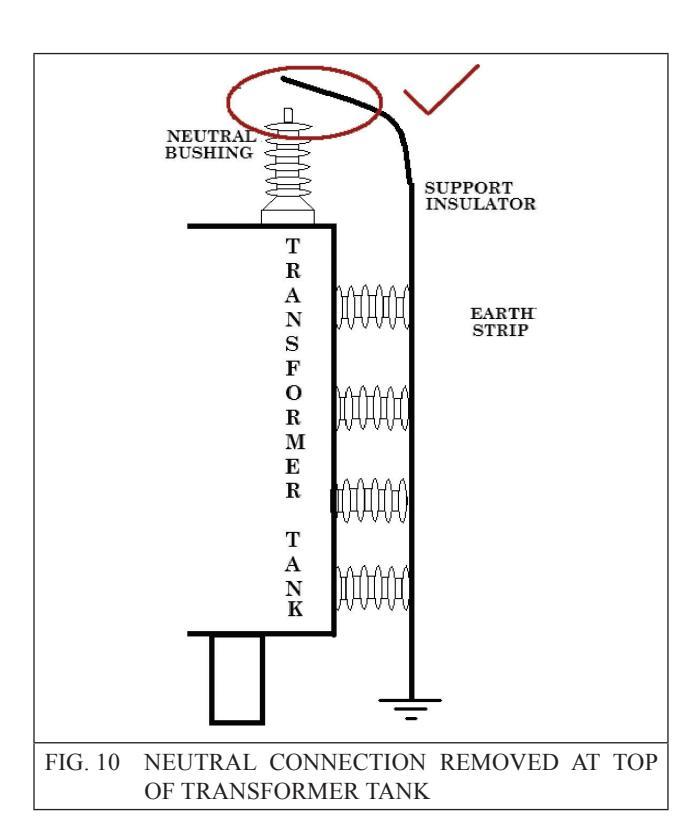
A major reduction in Tan Delta values was also seen in CH reading, as the support insulators with dirty surfaces were excluded from the measurements.

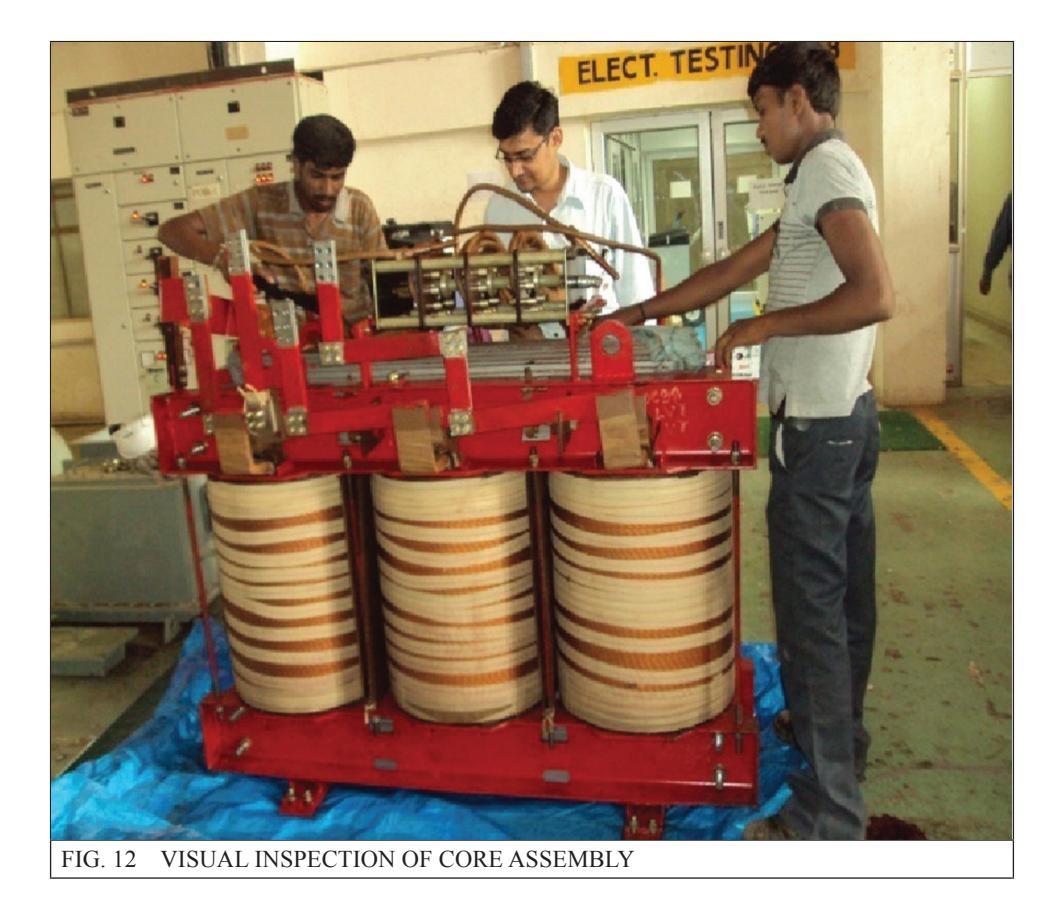
Figure 12 shows visual inspection of core assembly.

Hence, this transformer was opened at our workshop and after physical verification of core assembly, heavy water and other contaminations were observed between HV and LV windings. After necessary cleaning and heating cycle in oven, moisture content and other particles were removed and again Ten Delta test and other test were performed and results were found to be satisfactory as per Table 15.
