Effects of Common In-Service Defects of Different Insulators on Radio Frequency Interference Emission from 765 kV Insulators String

P. Rajamani*, K. Devender Rao and Pradeep M. Nirgude

Central Power Research Institute UHV Research Laboratory, Hyderabad - 500098, India; rajamani@cpri.in

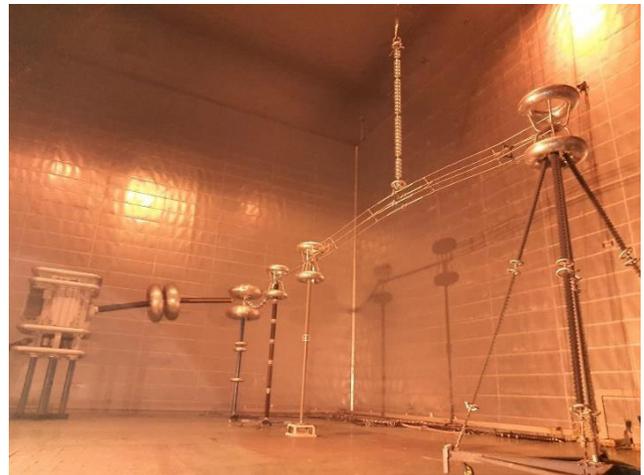
Figure 1. 765 kV glass disc insulator string with 5 damaged discs erected at double shielded indoor test facility for interference measurement.

Rodent damage or bird peaking is a common in-service defect in composite insulators. Birds usually peak insulator shed portion along the entire length of the insulator. However, to record the impact of rodent damage/bird peaking, some sheds on both the line and ground end are deliberately damaged as shown in Figure 7. Both rodent-damaged long rod insulators are arranged in series to form a single I suspension string. Damage to porcelain or glass disc insulators due to various reasons is the major in-service defect in the ceramic insulator strings. To study the influence of the damaged disc insulator on RFI, five discs are deliberately damaged as shown in Figure 8 and placed at equally spaced intervals along the entire length of the string from line end to tower end. As the glass insulators are made up of toughened glass, after damage only the stub is present and the stub is placed at equally spaced intervals on the sting from HV end to ground end. Inclusive of damaged insulators, the number of discs on each string in 41.765 kV, 210 kN glass single I suspension insulator string with 5 damaged insulators (only stub) is shown in Figure 1.

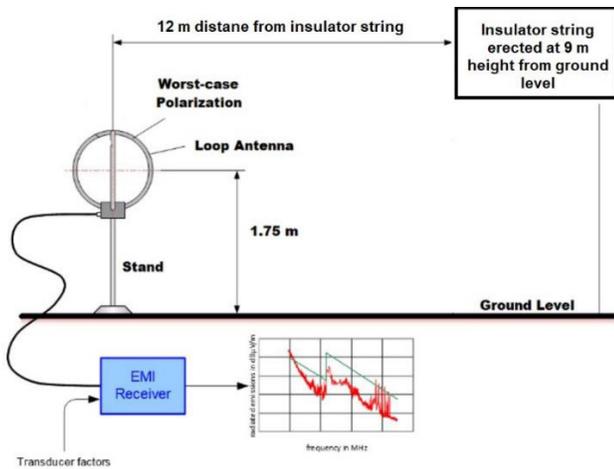
Figure 2. Recording of interference using loop antenna and EMI receiver.

CISPR compliance EMI test receiver, ESR3, used for the recording of RFI. This receiver is capable to record/measure RFI spectra up to 3.6 GHz in conjunction with suitable antennas viz, loop (9 kHz to 30 MHz), bi-conical (30 to 300 MHz) and logarithmic (300 to 1000 MHz). The specifications of the antenna also comply with the requirement of CISPR 16-1⁴. Figure 2 shows the schematic arrangement of interference measurement up to 30 MHz using a loop antenna.

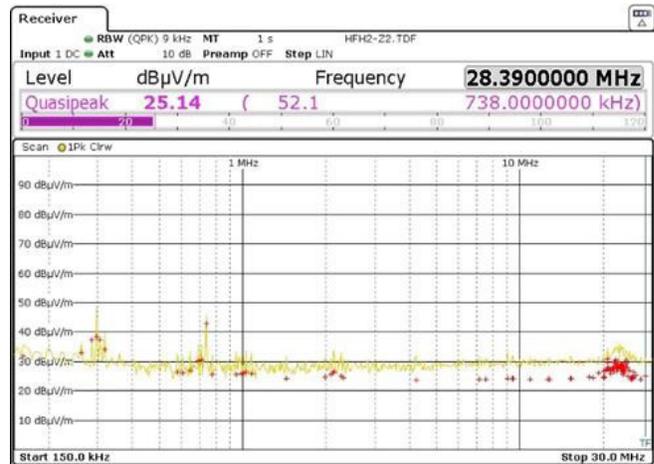
Figure 3. Ambient RFI measured from double shielded indoor test facility.

use QP detectors. But measurement with a QP detector is time-consuming, to record RFI to 30 MHz with 9 kHz bandwidth in the linear scale of frequency from 150 kHz requires approximately 90 minutes. But the peak detector records the interference faster compared to that the QP detector. Moreover, CIGRE 391 recommends using a combination of Peak and QP detectors for faster and more precise measurement of interference⁵. Hence, the measurement is performed with a peak detector and on the measured spectrum, peak search is performed with a QP detector. Identified Quasi-peaks are represented with red colour '+' mark on the spectra. A screenshot of RFI measured using an EMI test receiver and loop antenna oriented at worst-case polarization in the frequency sweep from 0.15 to 30 MHz inside a shielded laboratory is shown in Figure 3.

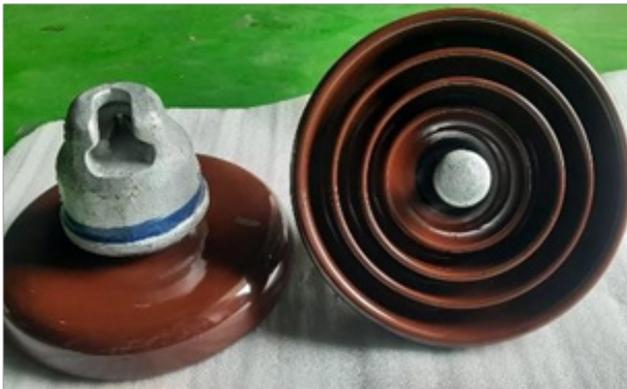
Figure 4. 210 kN porcelain disc insulator.

A single I suspension insulator string with hardware fittings suitable for quadruple ACSR moose conductors is chosen for comparative studies. The photograph of the 210 kN porcelain disc insulator used for comparative analysis is shown in Figure 4. Chosen porcelain disc insulator has a diameter of 280 mm and 41 discs are connected in series. As shown in Figure 1, an arcing horn with a ball diameter of 50 mm is used on the ground side and a corona control ring of 600 mm diameter is used on the HV side. The tube diameter of chosen corona control

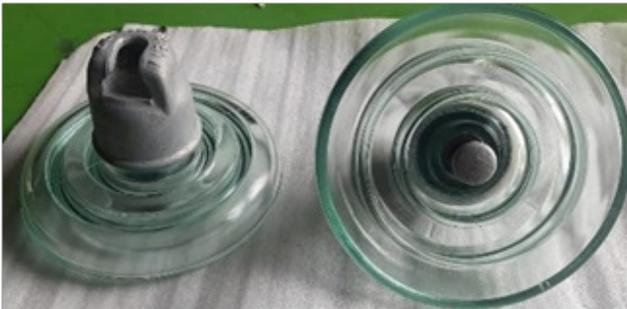
Figure 5. 210 kN Glass disc insulator.

ring is 60 mm. Similarly, a photograph of chosen 210 kN glass disc insulator is shown in Figure 5 and the diameter of this disc is also 280 mm. Similar hardware like porcelain insulator string is used for this string too. On the contrary, a 210 kN long rod composite silicone rubber long rod insulator as shown in Figure 6 is chosen for comparative studies. Two composite insulators connected in series form a 765 kV single I suspension composite insulator string with hardware fitting suitable for quadruple ACSR moose conductor. In composite insulator string, in addition to the corona control ring, 2 numbers 300 mm diameter tube grading rings are also used.

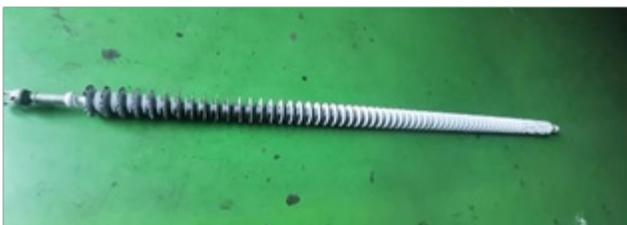
Figure 6. 210 kN composite silicone rubber long rod insulator.

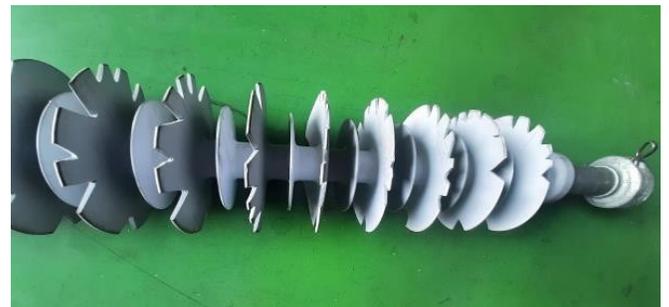
Figure 7. Deliberately damaged composite insulators like rodent/bird peaking damage.

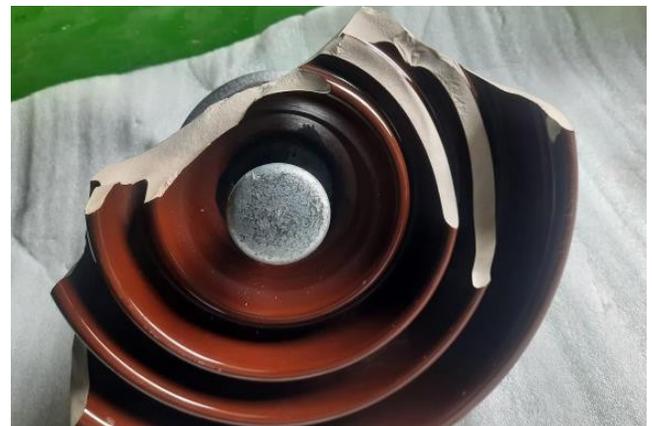
Figure 8. Deliberately damaged porcelain disc insulator.

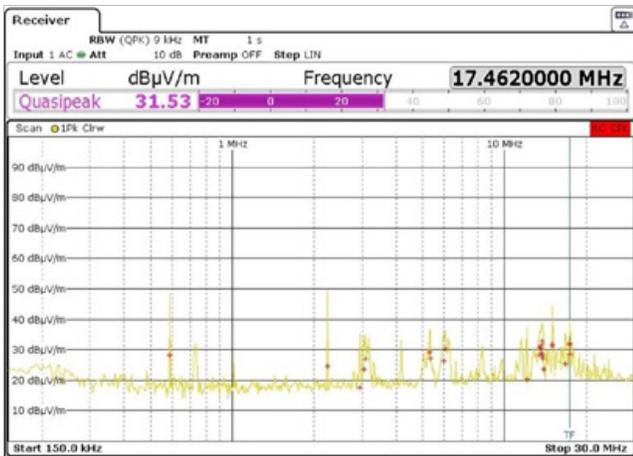
Figure 9. RFI emission of 765 kV healthy porcelain disc insulator string.

In general, utilities measure conducted radio interference voltage level from insulator string in the laboratory using coupling capacitors at a fixed frequency, i.e., at 1000 kHz at a test voltage of $1.1 \times \text{highest system voltage} / \sqrt{3}$. For the 765 kV system, the test voltage is $1.1 \times 800 / \sqrt{3} = 508$ kVrms. For this comparative analysis, 508 kVrms is used as the test voltage. The test sample is excited at this voltage and maintained for 300 seconds before recording RFI. As stated earlier in section II, the test sample, 765 kV, 210 kN single I suspension string with 41 number of healthy porcelain disc insulators are erected as in Figure 1 and the loop antenna is located at 12 m. As per measurement guidelines, before the application of test voltage, the worst-case orientation of the loop antenna is identified and RFI is recorded at that orientation only. Screenshot of interference recorded from a healthy porcelain insulator string at 508 kVrms after preconditioning at 300 seconds is shown in Figure 9. It is evident from Figure 9 that, compared to the ambient/background shown in Figure 3, few spikes are found between 2 to 23 MHz frequency. Spikes around 10 MHz are due to spark or gap discharges and spikes recorded around 5 to 10 MHz is from corona discharges. RFI recorded from 765 kV healthy glass disc and composite single I suspension string is shown in Figures 10 and 11. More-or-less same trend of RFI was observed from both glass and porcelain disc insulators. However, spectra from glass disc insulator string are different from others. In that, the contribution of corona discharges on interference was found minimum.

As stated in section II.E, three 765 kV, 210 kN single I suspension insulator strings were chosen. Ceramic insulator strings consist of 5 numbers of damaged disc insulators placed at equally spaced intervals from the line end of the string to the ground end. Interference was recorded at a test voltage of 508 kVrms after preconditioning for 300 seconds. Interference of string consisting of damaged porcelain and glass disc insulators are shown in Figures 12 and 13 respectively. It is evident from Figures 9 and 12 that a distinct difference in recorded spectra was found on healthy and damaged porcelain disc

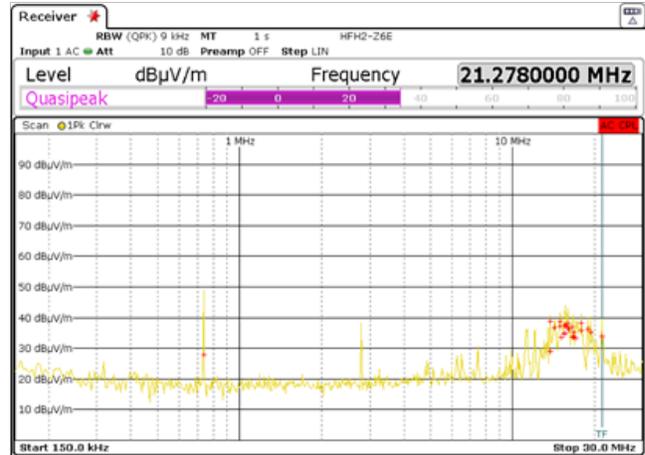
Figure 10. Measured RFI emission of 765 kV healthy glass disc insulator string.

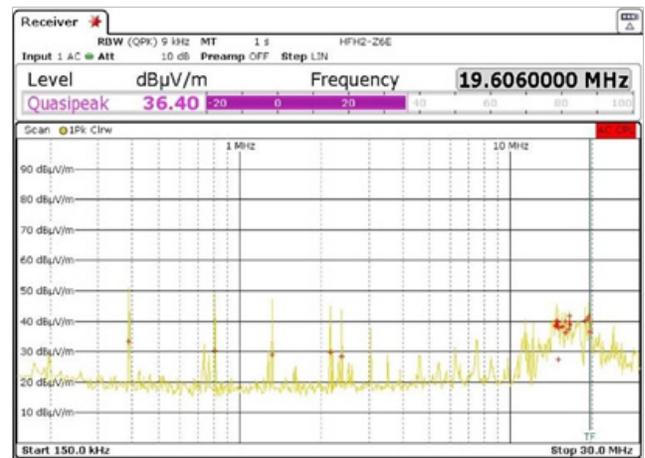
Figure 11. Interference was measured from a 765 kV healthy composite insulator string.

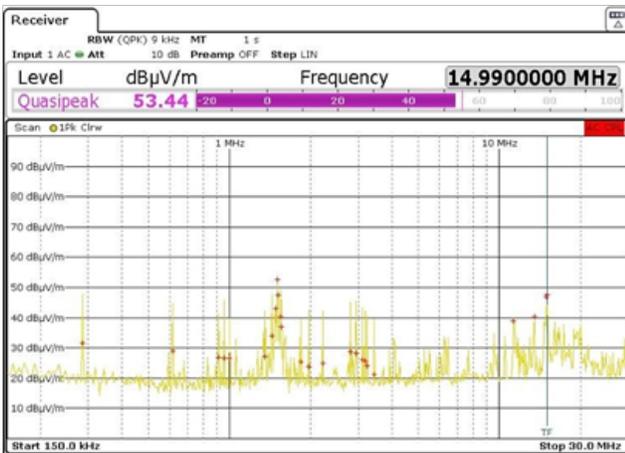
Figure 12. RFI recorded from 765 kV porcelain disc insulator string consisting of 5 damaged discs.

insulator string. Particularly, the intensity of interference is higher in the 4 to 6 MHz range. Corona is the contributing factor for interference emission at this frequency range and hence this higher magnitude of interference from string consists of a broken disc insulator. A similar trend is observed from glass disc insulator string consisting of healthy and broken glass disc insulators also. The magnitude of interference measured is lesser, this may be due to the presence of only stub on the string. Moreover, rodent damaged/bird-peaked composite insulator string is shown in Figure 14. Compared with RFI recorded from healthy composite insulator string, no major difference is observed, except for a few spikes on the low-frequency region.

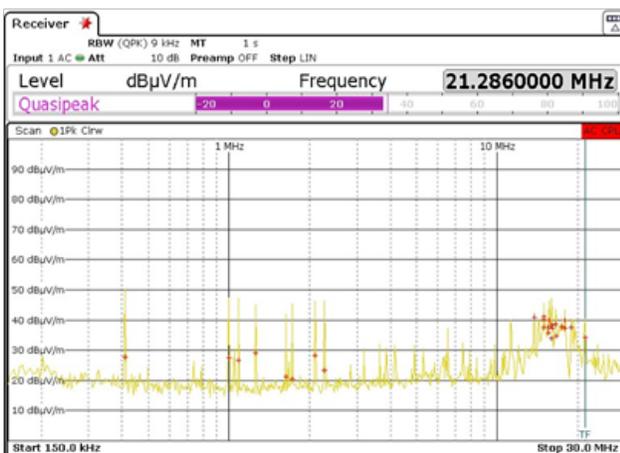
Figure 13. RFI recorded from 765 kV glass disc insulator string consisting of 5 damaged discs.

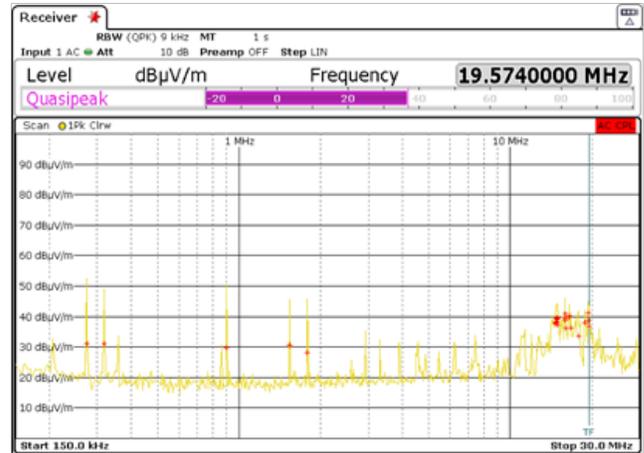
Figure 14. RFI rodent/bird peaking damaged composite long rod insulator string.

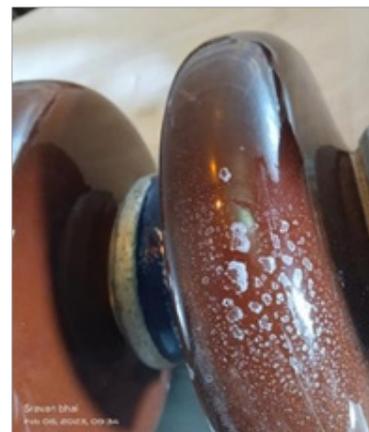
Figure 15. Porcelain disc insulator with salt water pollution applied on the surface.

To assess the impact of surface pollution on radio frequency interference emission, on the chosen ceramic disc insulator string, salt water having a salinity of 160 kg/m³ is sprayed using a commonly available commercial water sprayer. A photograph of salt pollution deposition on the surface of a porcelain disc insulator is shown in Figure 15. Similarly, the salt water sprayed composite disc insulator is shown in Figure 16. RFI recorded at 508 kVrms from both insulator strings with salt water sprayed is given in Figures 17 and 18. A distinct change in the trend and magnitude of RFI is due to corona and spark discharges.

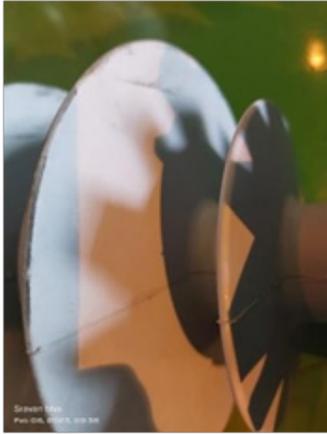
Figure 16. Composite insulator with salt water pollutants sprayed on the surface.

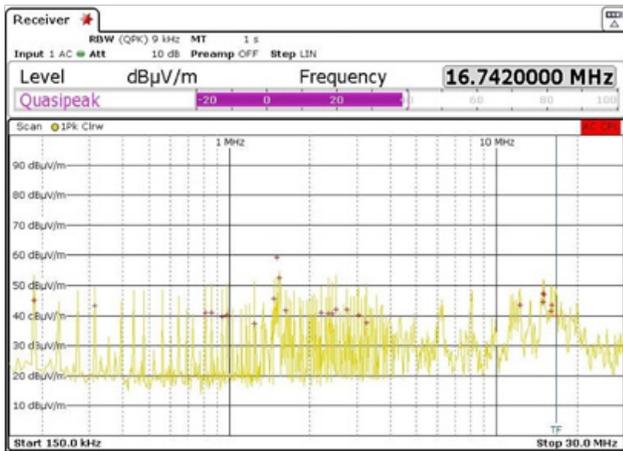
Figure 17. RFI of 765 kV porcelain disc insulator string coated with salt pollution spray.

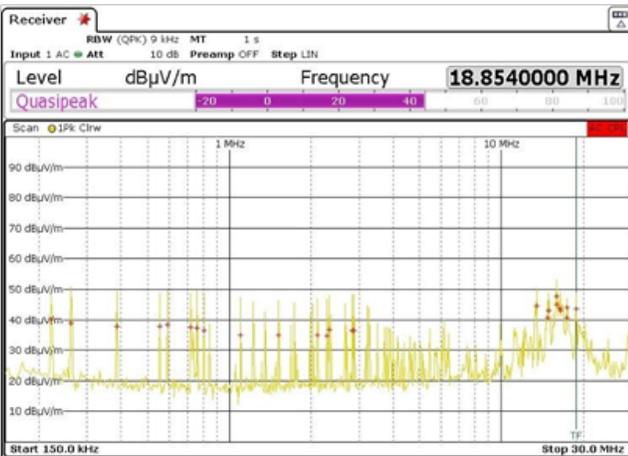
Figure 18. RFI of 765 kV polluted composite long rod insulator string.
