Study of the Effects of Fluorescence UV Radiation and Low Temperature on PVC Cable Outer Sheaths

Insulation Division, Central Power Research Institute, Bangalore – 560080, Karnataka, India;
moumita@cpri.in, ashitha@cpri.in, rakeshkg@cpri.in

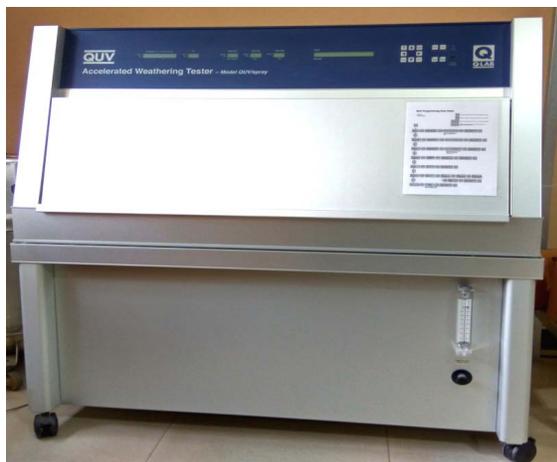
Figure 1. Accelerated weathering tester using fluorescent UV lamps.

Three commercially available PVC cable sheath samples were subjected to accelerated Fluorescence UV exposure facility with irradiance according to ASTM G 154 – 2016 in Accelerated weathering instrument from Q-Lab Corp i.e. a chamber using UVB-313nm fluorescent lamps with a set irradiance value of 0.71 W/m² at 313 nm, with a chamber temperature of 60±3°C with 4hrs dry and 4hr water spray at a chamber temperature of 50±3°C per cycle for 500 hrs. The instrument is shown in Figure 1.

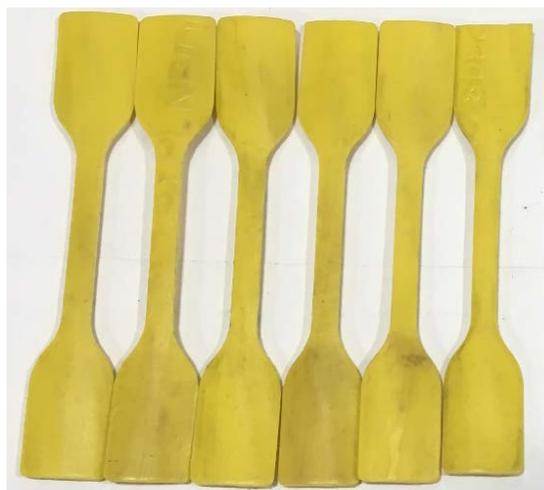
Figure 2. Colour change of PVC1 before UV ageing.

The colour change from yellow to brown was observed after 500 hrs UV ageing as shown in Figures 2 and 3 due to oxidation process.
