# Review of Failed Transmission Line Towers during Full Scale Testing

M. Selvaraj and Veerendra Kumar Shukla\*

Mechanical Engineering Division, Central Power Research Institute (CPRI), Bangalore – 560080, Karnataka, India;  
vshuklacivil@gmail.com

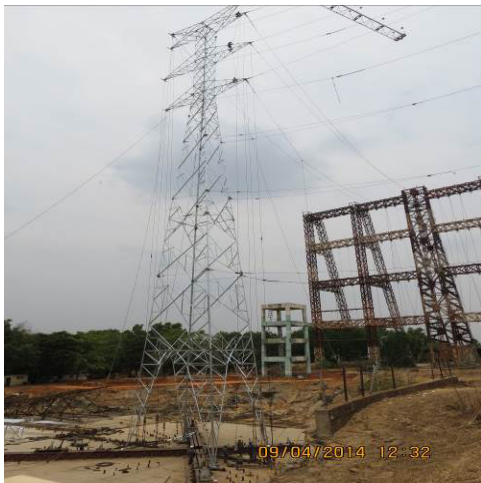
**Figure 2.** 220kV double circuit Tension tower.

**Description:** While increasing the loads from 75% to 90%, two Transverse bracing members and one Longitudinal bracing member buckled (Figure 2). Subsequently, Main leg got buckled below Ground wire level. The loads were released immediately.

Tower before test

**Remedial Measures:** The failed members were 80X80X6 MS Angle Section, after reanalyzing the tower, the existing member was replaced by 90X90X6 MS Angle Sections in the erected tower. Horizontal redundants of 45X45X5 MS size were also introduced on both transverse and longitudinal face to reduce the unsupported length of main member. After these remedial measures, the test was continued again and the tower was successfully tested.

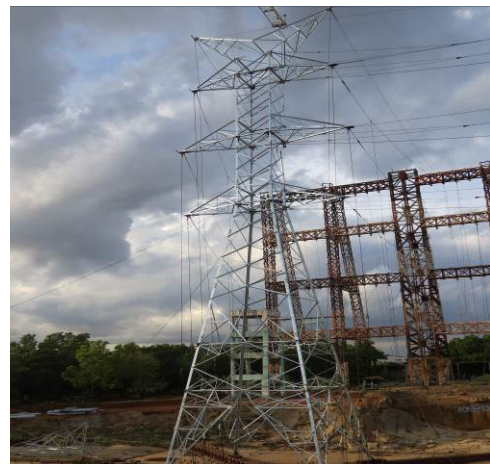
**Figure 3.** 220kV double circuit Tension tower.

**Description:** During waiting period after reaching 100%, of all loads, the tower failed. The failure occurred at compression leg members at the junction of first and second panel below waist level, (Figure 3). They started bowing outward. Subsequently the whole tower collapsed.

Tower before test

**Remedial Measures:** The tower was reanalyzed and after modification it was tested successfully.

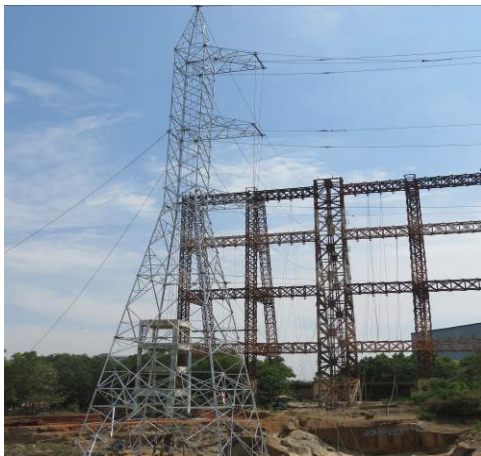
**Figure 4.** 220kV double circuit tension tower.

**Description:** During waiting period after 300 seconds, it was observed, that some bracing members of transverse and longitudinal face are slightly buckled, (Figure 4). The load was released immediately.

Tower before test

**Remedial Measures:** The buckled members were modified after reanalyzing the tower design. The existing member size L80X80X6 MS was replaced by L90X90X6 MS and L75X75X6 MS was replaced by L80X80X6 MS.

The tower was tested again after these modifications the tower was successfully withstood the loads under the above loading condition.

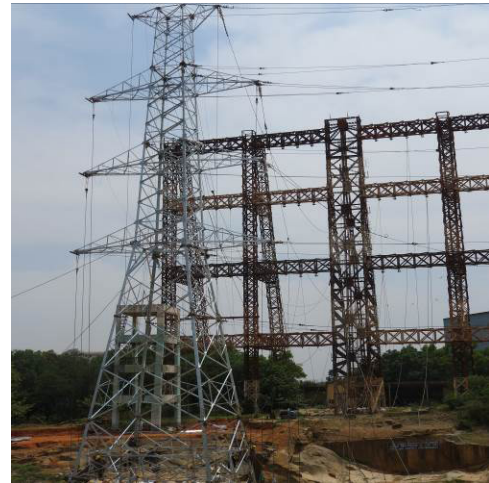
**Figure 5.** 66kV multi circuit tension tower.

**Description:** After completion of 240 seconds waiting period, it was observed that, redundant members of transverse side buckled (Figure 5). The loads were released immediately.

Tower before test

**Remedial Measures:** The buckled redundant members of existing size L45X30X4 were replaced by L45X45X4 and the test was continued again. The tower

was successfully withstood all the loads under the specified loading condition.

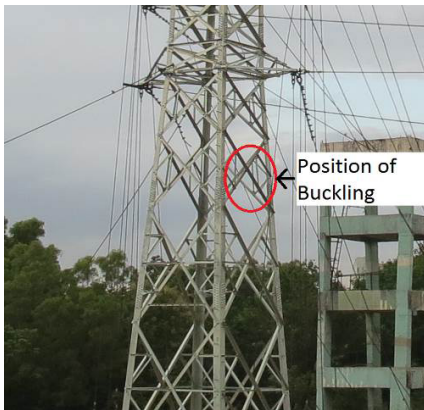
**Figure 6.** 220kV double circuit tension tower.

**Description:** While increasing all loads from 75% to 90%, one bolt sheared off at the joint of bracing and leg [Figure 6]. The loads were released immediately.

Tower before test

**Remedial Measures:** The bolt was replaced without any other modification in the tower. The testing was continued again and the tower was successfully –withstood all the loads under the above loading condition.

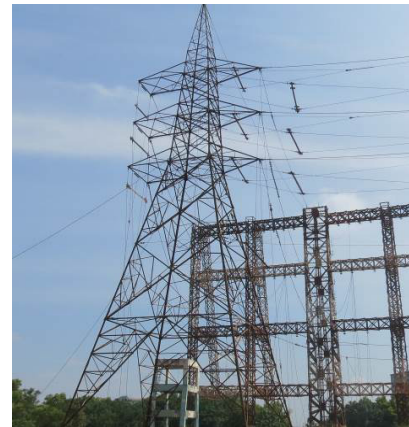
**Figure 7.** 230kV double circuit suspension tower.

**Description:** While increasing load from 95% to 100%, the tower failed. The failure started from leg member, which buckled below basic body and subsequently the whole tower collapsed, [Figure 7].

Tower before test

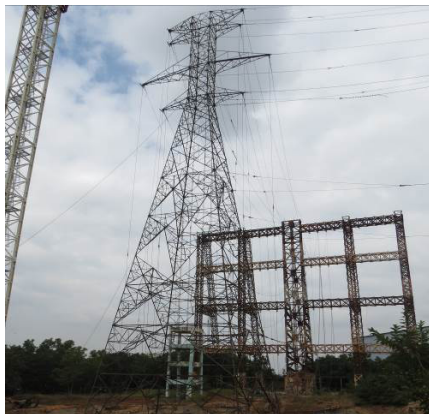
**Figure 8.** 330kV double circuit tension tower.

**Description:** Just after reaching 100% of all the loads, the tower failed. Failure started from Transverse bracing members and subsequently Leg members of Longitudinal side got buckled, [Figure 8]. All loads were released immediately.

Tower before test

**Remedial Measures:** Leg member of size L100X100X7 HT angle section was replaced by L100X100X8 HT angle section and bracing member was replaced with same size but unsupported length of the member was reduced by introducing L45X45X5 MS Angle sections. The tower was tested again and successfully withstood the loads pertains to the above loading condition.

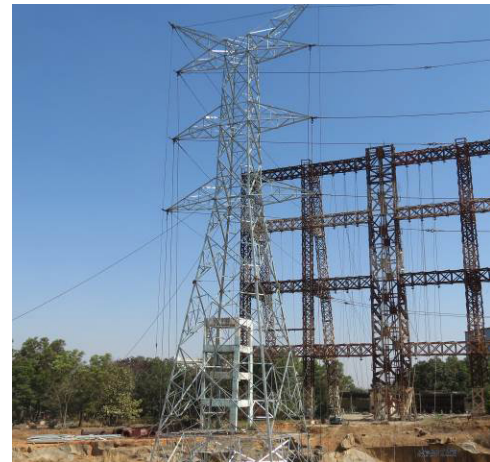
**Figure 9.** 400kV double circuit tension tower.

**Description:** After reaching 95% of loads, during waiting period, one bolt of Leg member was sheared off [Figure 9]. The loads were released immediately.

Tower before test

**Remedial Measures:** The bolt was replaced by a new bolt of same grade and test was resumed. The tower successfully withstood the load pertains to the above loading condition.

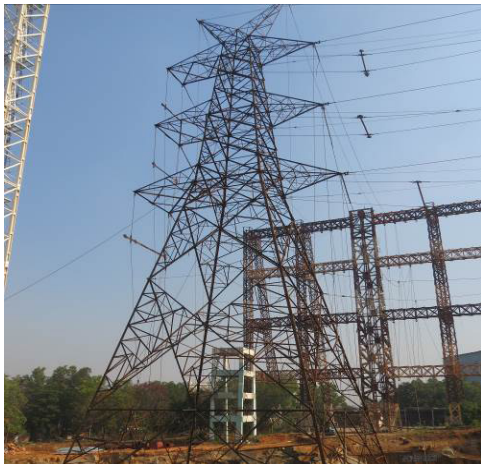
**Figure 10.** 132kV double circuit suspension tower.

**Description:** While increasing the transverse load to 100%, three bolts sheared off at the joint connecting Transverse Bracing and Leg [Figure 10]. The test was stopped immediately.

Tower before test

**Remedial Measures:** The bolts were replaced with same grade bolts and the test was continued. The tower successfully withstood the load pertains to the above loading condition.

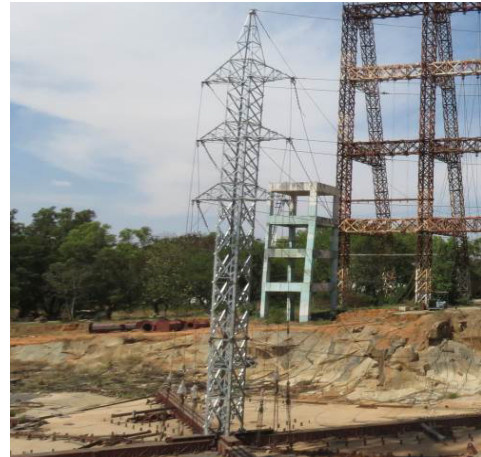
**Description:** During waiting period after reaching 100% of all the loads, some sound was heard from the tower [Figure 11]. On inspection, it was observed that one bolt was sheared off. The loading was stopped immediately.

Tower before test

**Remedial Measures:** The bolt was replaced with same Grade bolt and the test was started again. The tower successfully withstood the entire load after this modification.
