Analysis of Transformer Insulation by Tan Delta Testing Method

Dipak Mehta* and Hitesh R Jariwala**

This paper presents analysis of power transformer insulation by one fundamental insulation power factor test, also known as Tan Delta. It is a routine test conducted at site to know the healthiness of insulation in transformers. Out of 108 transformers tested for research work, case studies were chosen for analysis purpose. Experimental data shows our experience on the measurement of Tan Delta techniques of earthing systems and dryness of insulation in transformers. Result shows that the Tan Delta testing method is very efficient method.

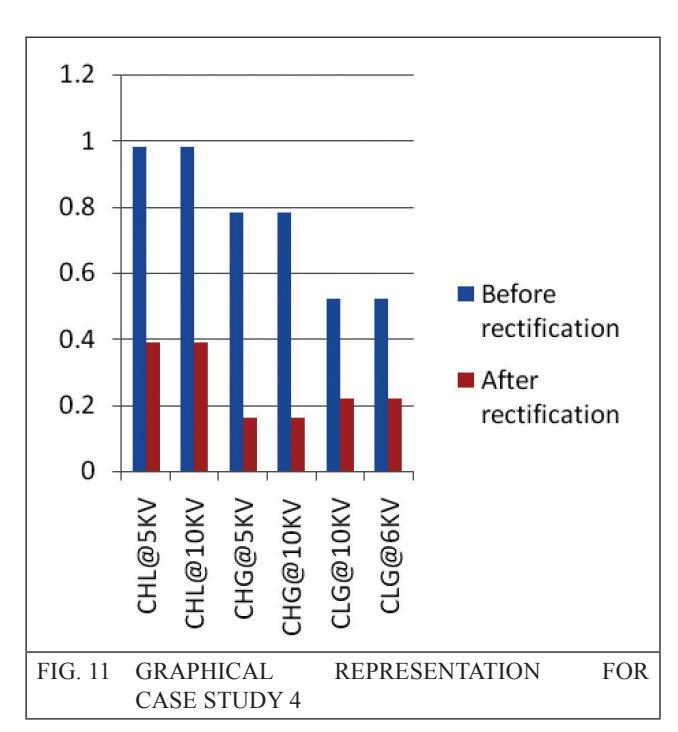
Figure 11 shows graphical comparison for Tan Delta values before and after repairing and rectification.

Т	ABLE 11		
TAN D STUDY 4 IY	TAN DELTA TEST RESULTS FOR CASE STUDY 4 AFTER NECESSARY CORRECTION IN NEUTRAL CONNECTION			
Insulation modeTest voltage kV% PF before rectification% PF after rectificatio				
CHL	5	0.98	0.39	
CHL	10	0.98	0.39	
CHG	5	0.78	0.16	
CHG	10	0.78	0.16	
CLG	2	0.52	0.22	
CLG	6	0.52	0.22
