Damage assessment of attemperator of thermal power plant boilers

Dhiraj M Gourkhede*

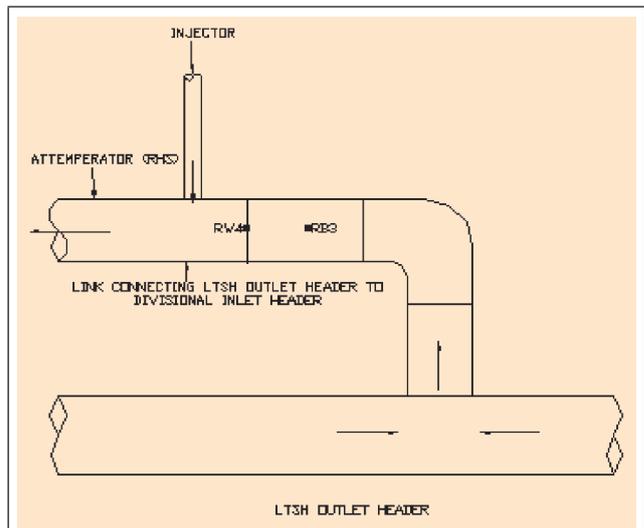
FIG. 12 ATTEMPERATOR (RHS)

The video images show the injector was intact & no damages were observed. The typical image obtained is shown in Figure 10.

IN-SITU Metallography and Hardness measurement was carried out near the injector on pipelines shown in the Figure 11.

Metallurgical analysis on the base and weld metal was conducted through in-situ metallography (replication) on external surface. The microstructure was further analysed in the laboratory and it reveals ferrite growth, grain boundary thickening on base metal. The Microstructure of weld metals reveals coarse bainite with spheroidised carbide precipitation [7]. The hardness readings were found within the acceptable range.
