Understanding impulse surface flashover phenomenon on thermally aged oil impregnated pressboard material

Surface flashover phenomena under lightning impulse voltage of positive and negative polarity on thermally aged Oil Impregnated Pressboard (OIP) material used in transformer is studied. OIP material with surface deposited Cu at different concentrations are also used for comparison. Total energy deposited on the OIP material and the magnitude of discharge current increased with ageing duration. The decay characteristics concerning optical emission from the surface flashover matched with the temporal decay of discharge current. The study also revealed some of the pre-breakdown phenomena before the main flashover breakdown. Optical Emission Spectroscopy (OES) revealed signature of diffused Cu and S in aged OIP material. Higher emission intensity for Cu was observed for higher aged OIP material, indicating larger possibility of degradation. OIP material collected from a failed transformer also showed optical emission lines matching with Cu emission, indicating possibility of employing the OES technique in contaminant detection. The temperature of the plasma during the surface flash

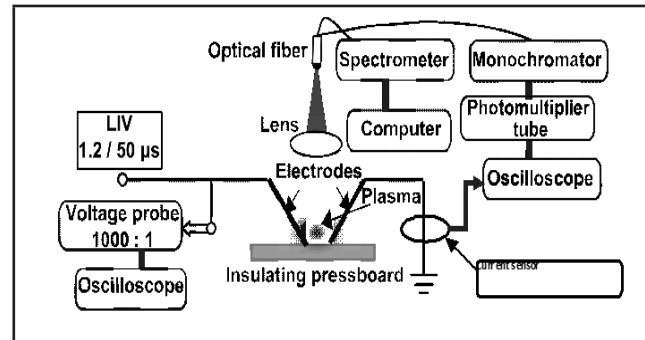
The setup for impulse surface flashover measurement is shown in Figure 1. A lightning impulse (1.2/50 μ s) voltage of positive and negative polarity are applied on the oil impregnated pressboard material adopting IEC 60112 electrode configuration [9] The voltage waveform was recorded during flashover using a 1000:1 voltage probe. A current sensor was used to observe the current variations during the process of flashover. The optical emission during the surface flashover was detected using a optical lens – fiber – coupled spectrometer with operating in UV-Visible region. A Photo Multiplier tube (PMT) was used to detect the temporal evolution of the optical signal from the surface flashover process. Pressboard material prepared using accelerated ageing (denoted as aged OIP) and surface deposition of Cu particles (denoted as Cu OIP) were used for the study. The method of preparation was described in [10]

FIG. 1. SCHEMATIC OF SURFACE POTENTIAL MEASUREMENT AFTER CORONA CHARGING USING ELECTROSTATIC VOLTMETER PROBE.

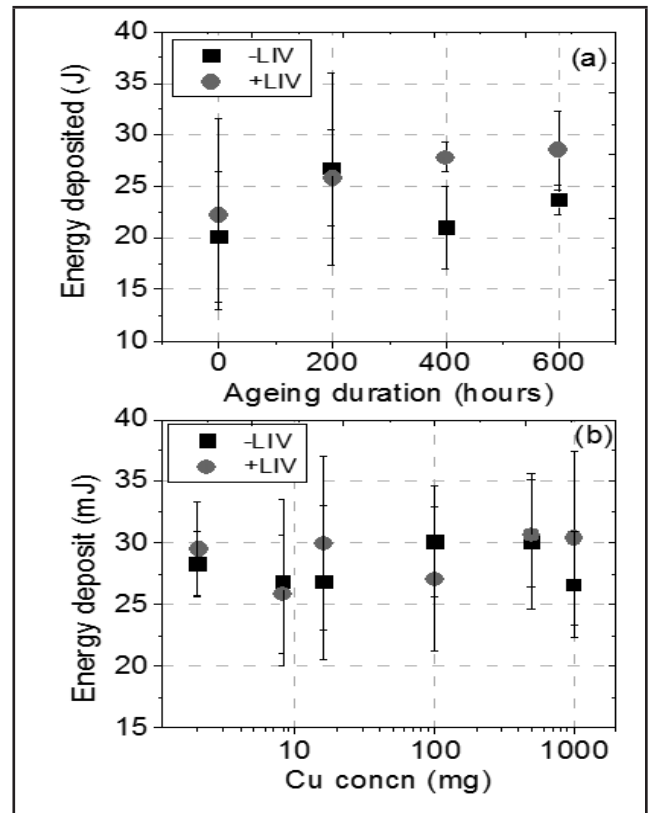
The total energy deposited on the insulating pressboard material during the surface flashover was calculated by time integrating the instantaneous power delivered to the material surface. The results for both type of samples under +/-LIV voltages are shown in Figure 3.

An increasing trend of energy deposited with increase in ageing duration was observed in the case of aged OIP material. However, the Cu deposited samples had a deposited energy of 25-30 J irrespective of the surface concentration. This indicated that flashover is affected by bulk properties, even though the process happens on the surface. A high voltage stress on the surface on the OIP material can cause flashover breakdown due to the presence of diffused Cu contaminant. The magnitude of discharge current during the flashover was also important to look at. Figure 4 shows the room mean squared magnitude of discharge current for aged and Cu deposited OIP material under flashover by +/-LIV. Similar to the trend observed in the case of deposited energy, the magnitude of discharge current during surface flashover increases for increase in ageing duration of oil impregnated pressboard. The magnitude of current is in the

FIG. 3. THE TOTAL ENERGY DEPOSITED ON THE SURFACE FOR (A) AGED OIP (B) CU DEPOSITED OIP

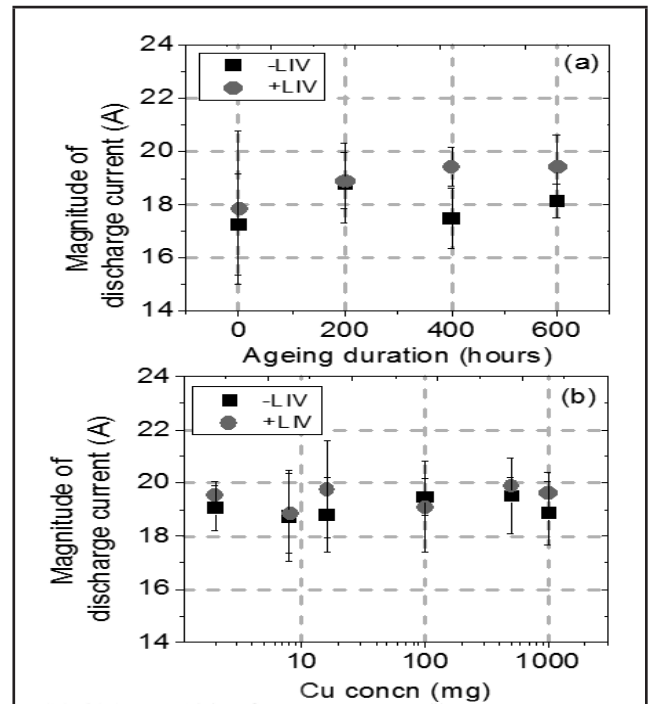
FIG. 4. MAGNITUDE OF DISCHARGE CURRENT DURING SURFACE FLASHOVER FOR (A) AGED OIP (B) CU OIP

range 18-20 A for Cu deposited OIP material.

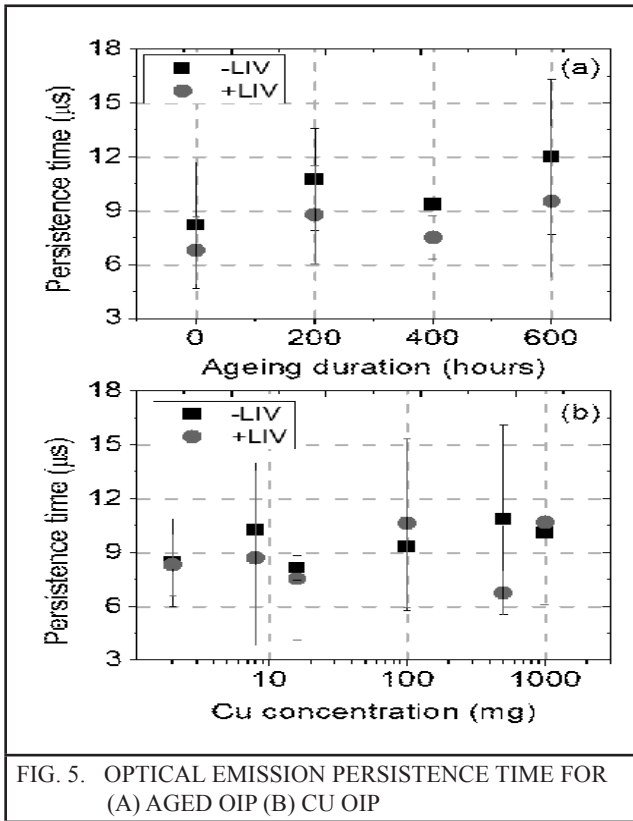
The optical emission during flashover, detected using PMT showed an exponentially decaying envelope pattern. The persistence time of the optical emission was estimated by calculating the time at which PMT signal decayed to 1/e of the initial amplitude. The persistence time of optical emission is shown in Figure 5. The aged OIP material showed an increase of optical emission persistence time with increase in the duration of ageing. The Cu deposited samples also showed a marginal increase in persistence with concentration.

FIG. 5. OPTICAL EMISSION PERSISTENCE TIME FOR (A) AGED OIP (B) CU OIP

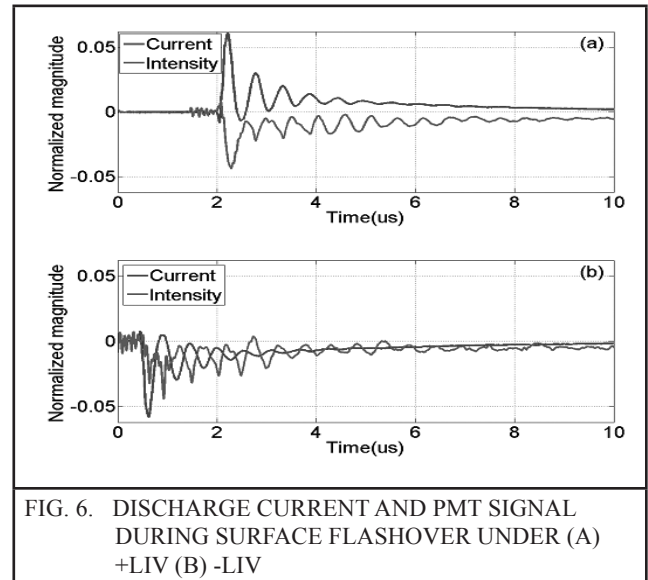
Figure 6 shows the correlation between the discharge current and the PMT signal of a typical impulse surface flashover. Since PMT is negative biased, on application of both +LIV (Figure (a)) and -LIV (Figure (b)) the decay is negative

exponential. It can be seen that the temporal decay of optical signal is well correlated with the decay of discharge current during surface flashover. The correlation existed in the case of both virgin and aged OIP material.

FIG. 6. DISCHARGE CURRENT AND PMT SIGNAL DURING SURFACE FLASHOVER UNDER (A) +LIV (B) -LIV

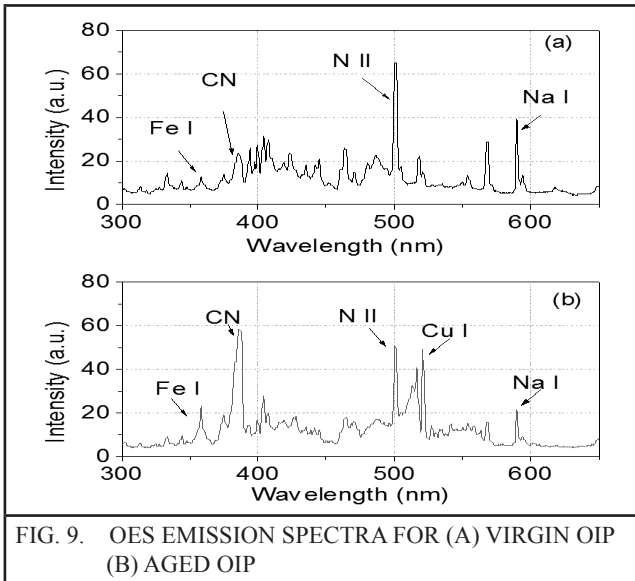
In the OES emission spectrum of aged OIP material is shown in Figure 9.

Cu I emission line was detected in the case of aged OIP material (Figure 9 (b)) which was not observed in OES emission spectrum of virgin OIP material (Figure 9 (a)). This confirmed the diffusion of copper contaminant into the OIP material due to thermal ageing.

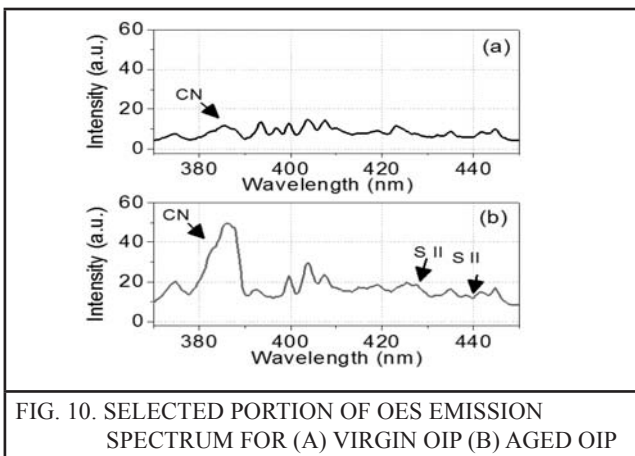
Presence of S II emission lines in trace intensities were also found in OES emission spectrum of aged OIP material as shown in Figure 10 (b). The corresponding OES spectrum of virgin OIP material (Figure 10 (a)) does not show the presence of S II emission lines. This indicated that sulphur contaminant has diffused into the aged OIP material due to ageing. Both Cu I and S II emission lines were in agreement with NIST database [11]

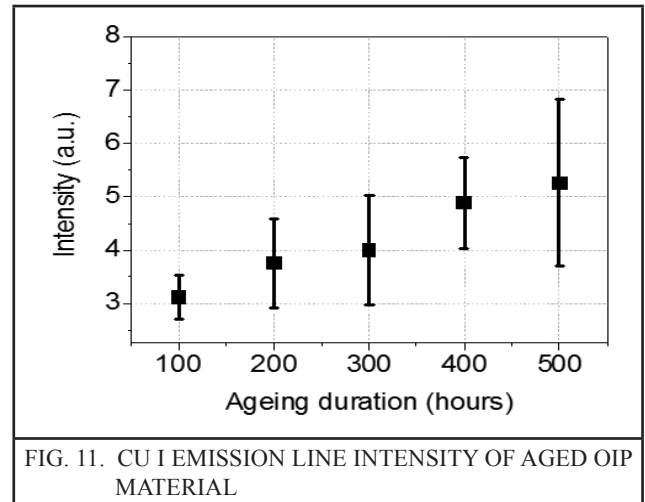
The intensity of Cu I emission line was estimated for aged OIP material of different ageing durations as shown in Figure 11. A marginal increase in Cu

I intensity was observed with increase in ageing duration of OIP material. Surface flashover was found to occur at a lower voltage in the case of aged OIP material [10]. This indicated that a longer aged OIP material has a larger chance of surface flashover.

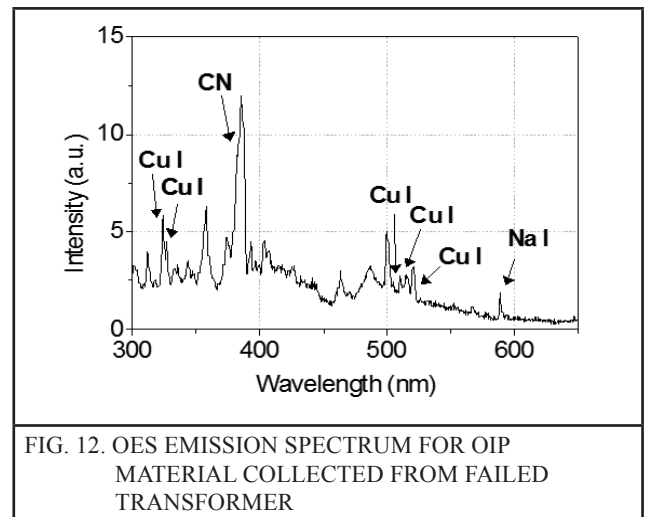
Surface flashover studies were also carried out on OIP material collected from a failed transformer (16 MVA, 110/33-11 kV). The OES emissions were captured as shown in Figure 12.

Five Cu I emission lines were visible in the OES emission spectrum indicating clearly the presence of diffused Cu contaminant in the insulating OIP material of the failed transformer. OES study was carried out on various positions on the OIP material from failed transformer. The intensity of Cu I emission lines were varying with position. Largest intensity was observed in the positions

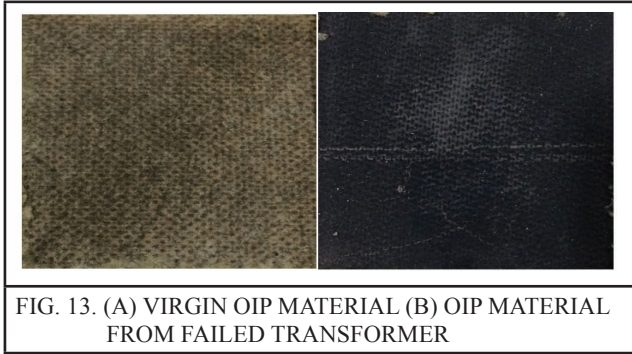
with darker colour on the surface. The image of the surface of the OIP material from field transformer is shown in Figure 13. Figure 13 (a) shows virgin OIP material and Figure 13 (b) shows OIP material from the failed transformer.

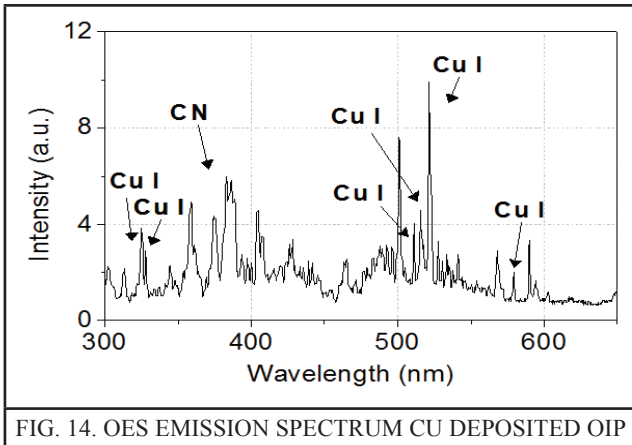
In the Cu deposited OIP material, optical emission during surface flashover was captured as shown in Figure 14. Several Cu I emission lines were observed in the OES spectrum. This is due to the discharge during surface flashover passing through the deposited Cu layer. Presence of several Cu I lines in the spectrum allows us to estimate plasma temperature at different concentrations of Cu on the pressboard surface. Boltzmann-Saha equations are used for calculating the plasma temperature. The parameters used are shown in Table 2.

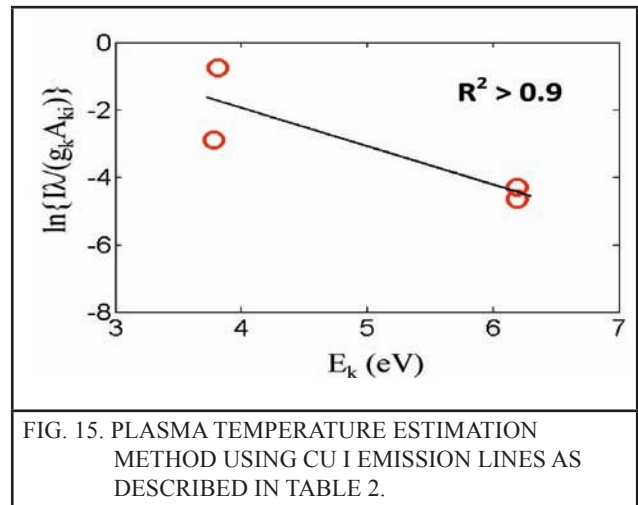
For the temperature estimation, a linear fit was performed between E_k and for suitable Cu I lines as shown in Figure 15 where I is the intensity of a particular emission line, λ is the wavelength, E_k is the upper energy level, E_i is the lower energy level, g_k is the upper level degeneracy and A_{ki} is the transition probability of a particular transition. In the case of field OIP material, 3 available Cu I lines were used for the calculations while for Cu OIP, 4 lines were used. Negation of the inverse of slope of the linear fit gives plasma temperature.

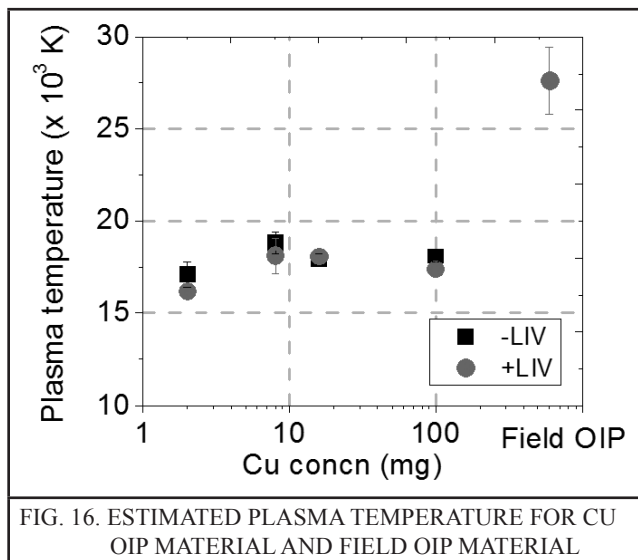
Estimated plasma temperature of Cu plasma for Cu OIP material and field OIP material from failed transformer are shown in Figure 16. For low deposition concentrations of Cu OIP material, plasma temperature is about 16×10^3 K while for larger concentrations, plasma temperature raises upto 19×10^3 K. For field OIP material, plasma temperature is much larger, it is in the order of 28×10^3 K. This indicates that during surface flashover, field OIP is heated up much more than Cu OIP. This can be attributed to the increased degradation for field OIP material. Plasma

temperature during surface flashover can be taken as an indication of severity of degradation. Further study is essential to use the proposed OES technique for field measurements.

FIG. 16. ESTIMATED PLASMA TEMPERATURE FOR CU OIP MATERIAL AND FIELD OIP MATERIAL

flashover was found to be 19×10^3 K for Cu OIP and 28×10^3 K for field OIP material.
